# **vibration Analysis Report**

## **ENI oil company** **GT 6 Gas Generator, Turbine,** **GEARBOX & Alternator** **20<sup>th</sup> - 30<sup>th</sup> January 2007**

A Vibration Analysis was requested by an International Maintenance Service Company, on GT 6 Gas Generator, Turbine, Gearbox & Alternator set at an ENI Oil site, in Libya.

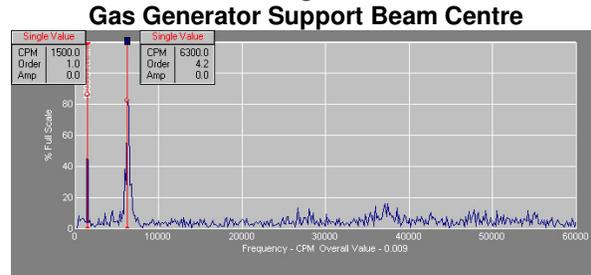
**Fig 1**

The bump test on the gas generator support beam indicated resonant frequencies at 1500cpm and 6300cpm (See Fig 1 gas generator support beam centre)

Although the gas generator beam showed resonant frequencies of 1500cpm & 6300cpm the rotating frequency of the gas generator is 7000cpm to 11000cpm, so this beam raised no concerns. The alternator beams indicated resonance's between 6450cpm & 14700cpm, as the alternator has a rotating frequency of 1500cpm these 2 beams also raised no concerns.

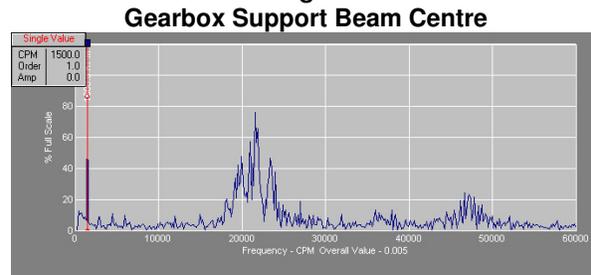
**Fig 2**

The bump test on the gearbox support beam indicated a resonant frequency at 1500cpm (See Fig 2 gearbox support beam centre)

However the gearbox support beam showed a resonant frequency of 1500cpm, this matched the output speed of the gearbox and immediately became a concern.

It was recommended to Siemens to remove the resonance from gearbox support beam.

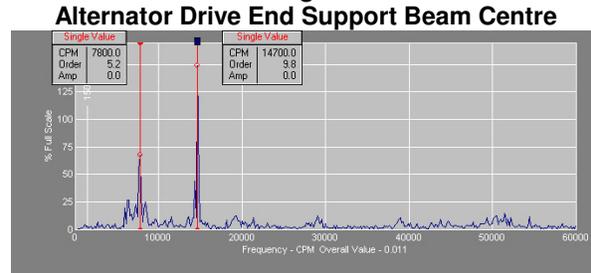
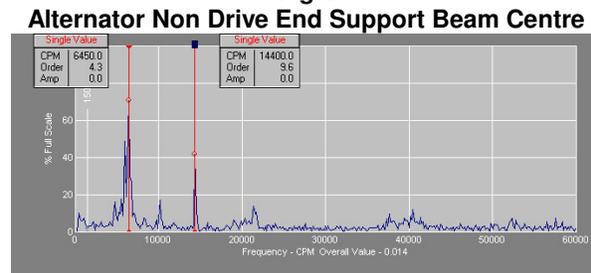
The bump test on the alternator support beams indicated resonant frequencies on the drive end beam at 7800cpm and 14700cpm (See Fig 3 alternator drive end support beam centre), and the non drive end beam at 6450cpm and 14400cpm (See Fig 4 alternator non drive end support beam centre)

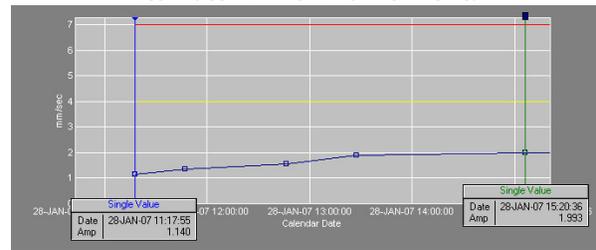
**Fig 5**  
**Alternator Drive End Horizontal**

During the run on the 28<sup>th</sup> January the vibration on the alternator remained at a steady and acceptable level (See Fig 5 alternator drive end horizontal)

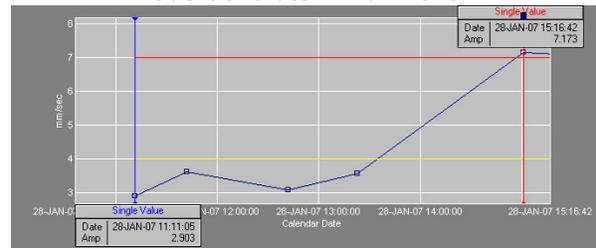
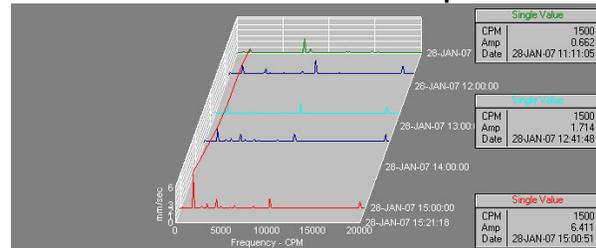
However during this run the axial vibration on the gas generator, turbine and input of the gearbox started to increase due to a frequency of 1500cpm (See Fig 6 gas generator axial trend & Fig 7 gas generator axial waterfall spectrum)

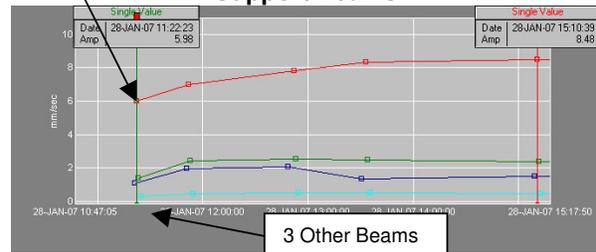
**Fig 8**  
**Support Beams**

The increases from the gas generator, turbine and gearbox input, matched the increases on the gearbox support beam, which had substantially higher vibration than the other 3 beams. The vibration on this beam increased from 5.9mm/s to 8.4mm/s due to the 1500cpm resonant frequency. (See Fig 8 support beams).

It was also explained that although the Siemens report (Ref 2006/361) suggested the gearbox support beam was 'rocking', it was in fact resonating. When this beam began to resonate, it initiated an axial movement along the set.

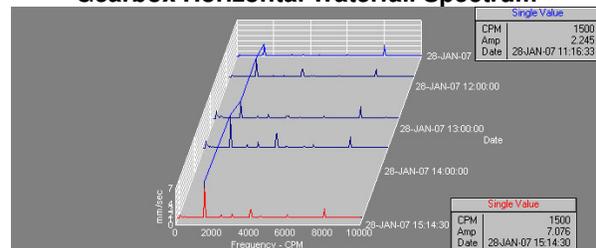
**Fig 9**  
**Gearbox Horizontal Waterfall Spectrum**

Although the vibration was increasing, the levels reported by Siemens in their report (Ref 2006/361) of 14.5mm/s on the gearbox horizontal was not reached (See Fig 9 gearbox horizontal waterfall spectrum). It was therefore decided to leave the unit running overnight at 2mw and to carry on with the data collection the following day

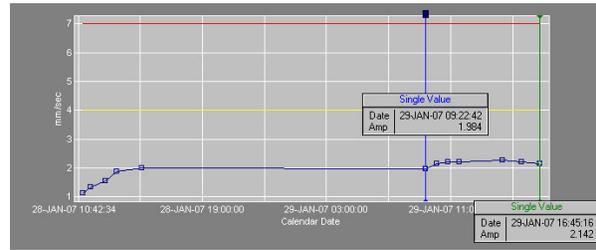
**Fig 10**  
**Alternator Drive End Horizontal**

After re-starting, the unit was run at 2mw and data taken over a seven hour period. During this time the vibration on the alternator remained steady and at an acceptable level (See Fig 10 alternator drive end horizontal)

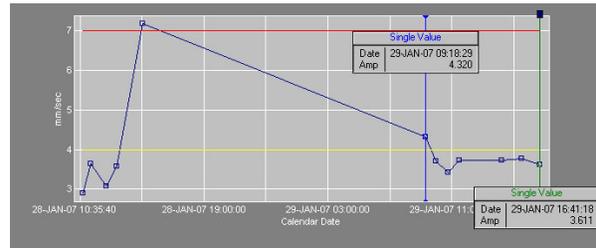
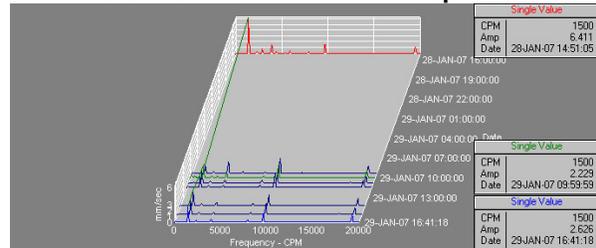
Also over the seven hour period the axial vibration on the gas generator remained at an acceptable level (See Fig 11 gas generator axial trend & Fig 12 gas generator axial waterfall spectrum), this was due to the 1500cpm been at a reduced level and remaining steady.

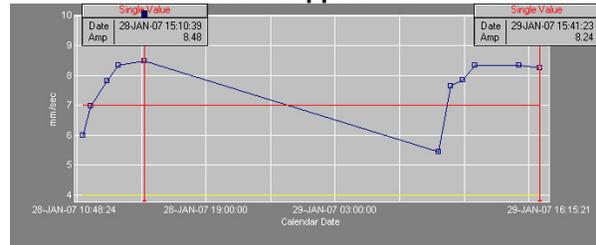
**Fig 13**  
**Gearbox Support Beam**

Although the gearbox support beam vibration remained high (See Fig 13 gearbox support beam), the 1500cpm resonant frequency was at half of the previous days level.
