condition monitoring
Report
Report ID
customer.
day. month. year

Line One

Report

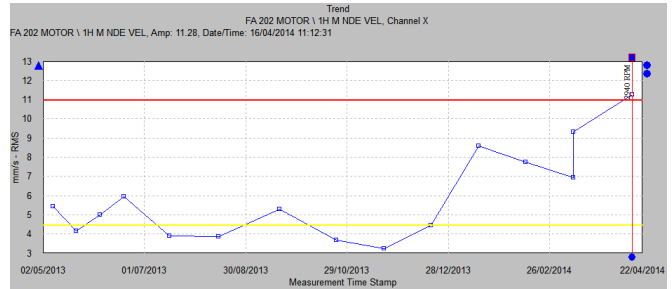
Motor Non Drive End Horizontal Vibration Trend 1H

As discussed during the site visit the noise level and vibration has increased on this unit. The increase in vibration on this unit isn't due to an increase in 1x vibration but turbulence possibly caused by air flow restriction (See motor non drive end horizontal vibration trend & waterfall spectrum 1H).

Increased Turbulence

Due to the increase in air turbulence I would recommend checking the dampner settings and pipe work for any blockages/restrictions

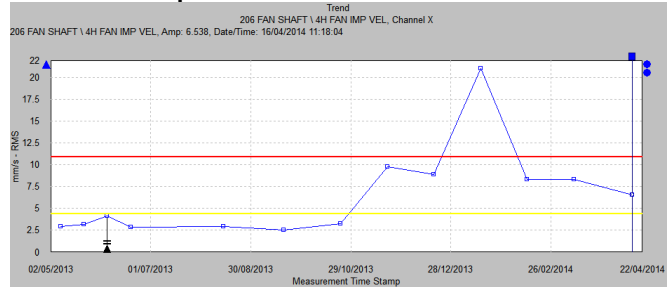
Fan Shaft Impellor End Horizontal Vibration Trend 4H

Although at a reduced level the vibration remains above 'baseline' levels (See fan shaft impellor end horizontal vibration trend 4H).

The increased vibration is due to 1x rpm frequency, I would therefore recommend inspecting the impellor for wear/damage and check it is free from build up.

If the impellor is in a satisfactory condition check all holding down bolts are tight and secure, then re-align the motor and fan shaft.

If the vibration remains above 'baseline' levels after the above corrective actions have been carried out, I would recommend the impellor is in-situ balanced.

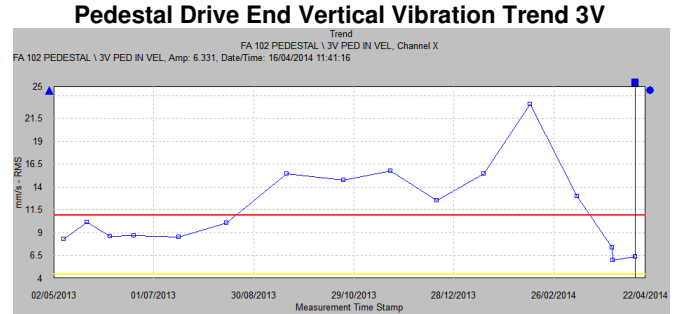
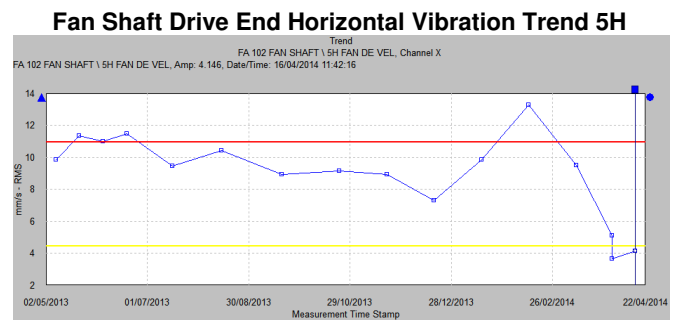
Following the re-setting and re-alignment of the motor/pedestal coupling and the in-situ balancing of the impellor, the vibration on the unit has reduced to an acceptable level (See pedestal drive end vertical vibration trend 3V & fan shaft drive end horizontal vibration trend 5H).

We will use these levels as the new 'baseline'.

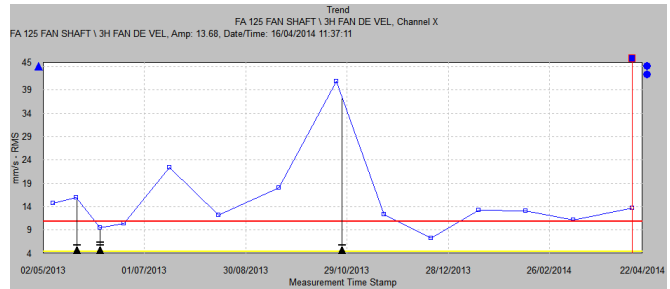
Fan Shaft Drive End Horizontal Vibration Trend 3H

The vibration on the fan shaft drive end remains at a higher than acceptable level (See fan shaft drive end horizontal vibration trend 3H).

New balanced pulleys are to be fitted to the unit, following this work we will assess the fan shaft vibration and report accordingly.
