# **vibration Analysis Report**

## **CROWN JEDDAH BEVERAGE**

### **CAN FACTORY.**

**13<sup>th</sup> / 19<sup>th</sup> FEBRUARY**

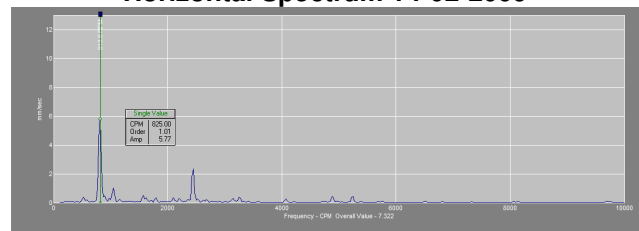
**Fig 1**  
**Fan Shaft Drive End Bearing**  
**Horizontal Spectrum 14-02-2009**

The overall vibration in the horizontal direction was 7.3mm/s with a 1x (814rpm) frequency of 5.7mm/s (**See Fig 1 Fan Shaft Drive End Bearing Horizontal Spectrum**).

Although the vibration was at acceptable levels using ISO Standard 2372, a decision was made to trim balance the fan to an improved level.

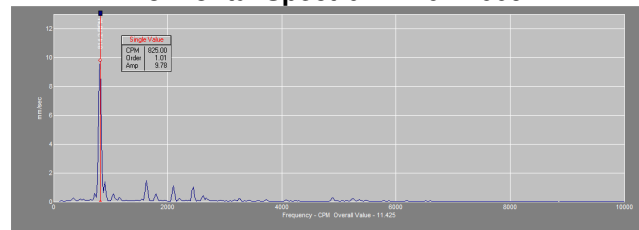
**Fig 2**  
**Fan Shaft Non Drive End Bearing**  
**Horizontal Spectrum 14-02-2009**

The overall vibration in the horizontal direction was **11.43mm/s** with a 1x (814rpm) frequency of 9.7mm/s (**See Fig 2 Fan Shaft Non Drive End Bearing Horizontal Spectrum**).

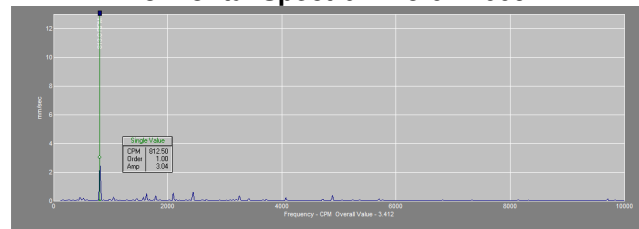
**Fig 3**  
**Fan Shaft Drive End Bearing**  
**Horizontal Spectrum 15-02-2009**

After the trim balance the overall vibration in the horizontal direction reduced to 3.4mm/s with a 1x (814rpm) frequency of 3mm/s (See Fig 3 Fan Shaft Drive End Bearing Horizontal Spectrum).

This unit was trim balanced to an improved level using one weight of 180grams, which was permanently attached (welded) to the 'boss' of the non drive end impellor.

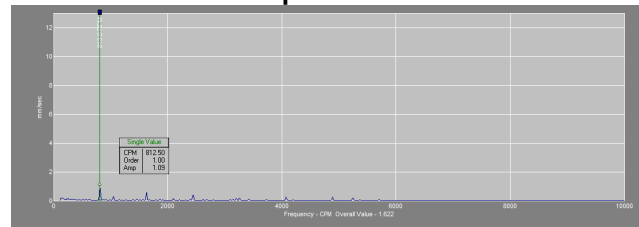
**Fig 4**  
**Fan Shaft Non Drive End Bearing**  
**Horizontal Spectrum 15-02-2009**

After the trim balance the overall vibration in the horizontal direction reduced to 1.6mm/s with a 1x (814rpm) frequency of 1mm/s (See Fig 4 Fan Shaft Non Drive End Bearing Horizontal Spectrum).

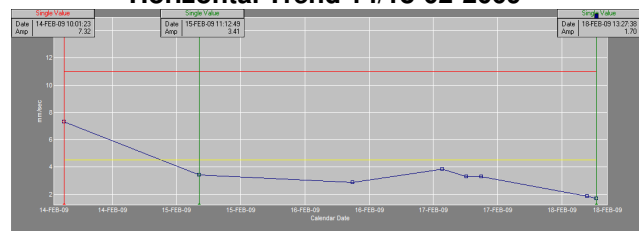
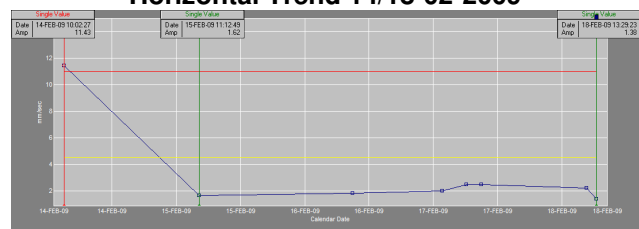
The unit was then monitored at various times over the following days until was running back at full temperature. The vibration remained at the improved level (See Fig 5 & 6 Fan Shaft Bearing Horizontal Trends).

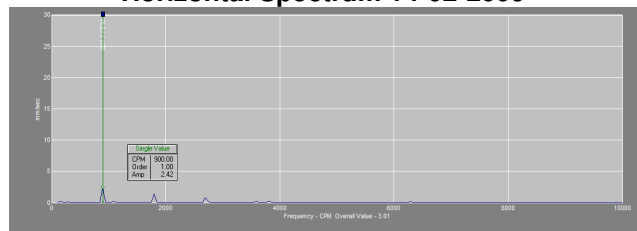
**Fig 7**  
**Fan Shaft Drive End Bearing**  
**Horizontal Spectrum 14-02-2009**

The overall vibration in the horizontal direction was 3mm/s with a 1x (897rpm) frequency of 2.4mm/s (See Fig 7 Fan Shaft Drive End Bearing Horizontal Spectrum).

Due to the amplitude of the non drive end bearing reading in the horizontal direction, a decision was made to trim balance the fan to an improved level.

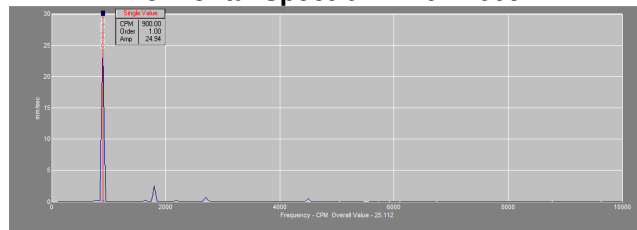
**Fig 8**  
**Fan Shaft Non Drive End Bearing**  
**Horizontal Spectrum 14-02-2009**

The overall vibration in the horizontal direction was **25.1mm/s** with a 1x (897rpm) frequency of **24.9mm/s** (See Fig 8 Fan Shaft Non Drive End Bearing Horizontal Spectrum).

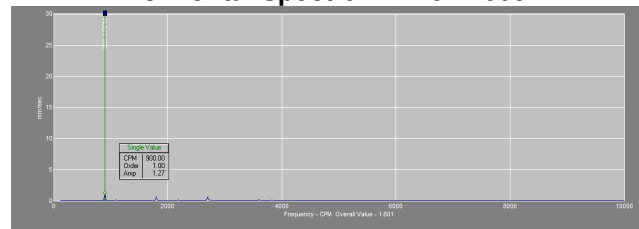
**Fig 9  
Fan Shaft Drive End Bearing  
Horizontal Spectrum 14-02-2009**

After the trim balance the overall vibration in the horizontal direction reduced to 1.6mm/s with a 1x (897rpm) frequency of 1.2mm/s (See Fig 9 Fan Shaft Drive End Bearing Horizontal Spectrum).

This unit was trim balanced to a satisfactory level using one weight of 205grams, which was permanently attached (welded) to the 'boss' of the non drive end impellor.

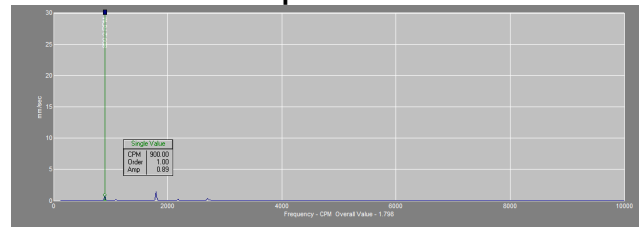
**Fig 10  
Fan Shaft Non Drive End Bearing  
Horizontal Spectrum 14-02-2009**

After the trim balance the overall vibration in the horizontal direction reduced to 1.8mm/s with a 1x (897rpm) frequency of 0.8mm/s (See Fig 10 Fan Shaft Non Drive End Bearing Horizontal Spectrum).

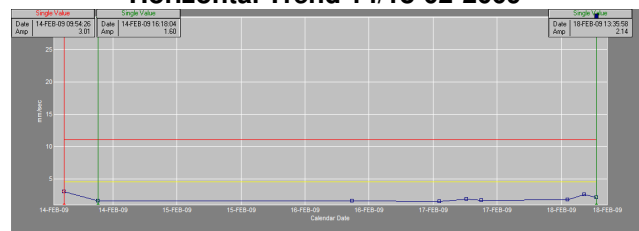
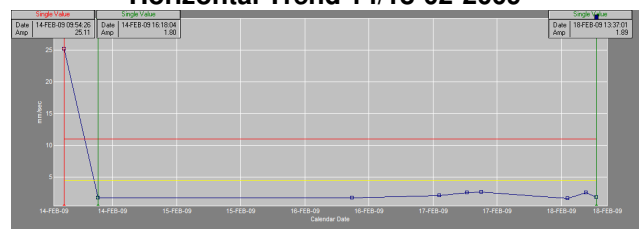
The unit was then monitored at various times over the following days until running back at full temperature. The vibration remained at the improved level (See Fig 11 & 12 Fan Shaft Bearing Horizontal Trends).

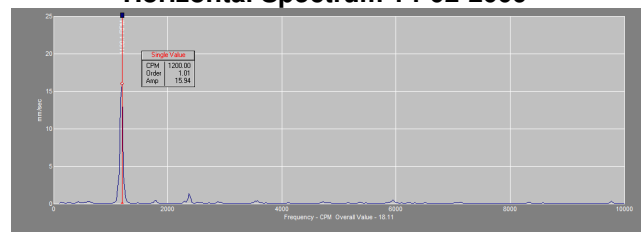
**Fig 13**  
**Fan Shaft Drive End Bearing**  
**Horizontal Spectrum 14-02-2009**

The overall vibration in the horizontal direction was **18.1mm/s** with a 1x (1188rpm) frequency of **15.9mm/s** (See **Fig 13 Fan Shaft Drive End Bearing Horizontal Spectrum**).

The overall vibration in the vertical direction was **18.6mm/s** with a 1x (1188rpm) frequency of **16.1mm/s**.

Due to the amplitude of readings on this unit, a decision was made to trim balance the fan to an improved level.

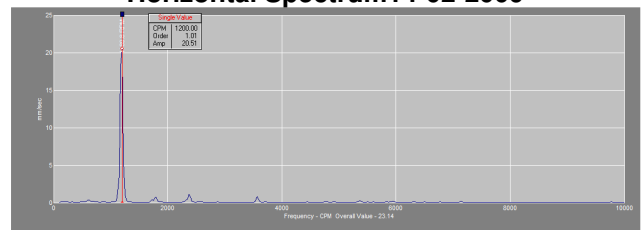
**Fig 14**  
**Fan Shaft Non Drive End Bearing**  
**Horizontal Spectrum 14-02-2009**

The overall vibration in the horizontal direction was **23.1mm/s** with a 1x (1188rpm) frequency of **20.5mm/s** (See **Fig 14 Fan Shaft Non Drive End Bearing Horizontal Spectrum**).

The overall vibration in the vertical direction was **27.1mm/s** with a 1x (1188rpm) frequency of **24.1mm/s**.

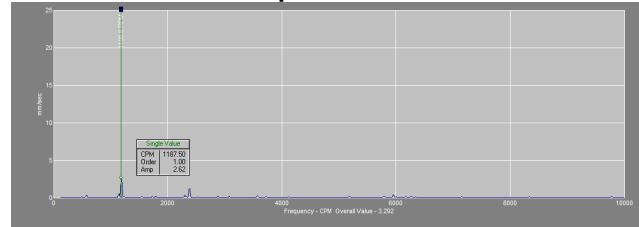
**Fig 15**  
**Fan Shaft Drive End Bearing**  
**Horizontal Spectrum 15-02-2009**

After the trim balance the overall vibration in the horizontal direction reduced to 3.2mm/s with a 1x (1188rpm) frequency of 2.6mm/s (See Fig 15 Fan Shaft Drive End Bearing Horizontal Spectrum).

This unit was trim balanced to a satisfactory level using one weight of 285grams, which was permanently attached (welded) to the 'boss' of the non drive end impellor.

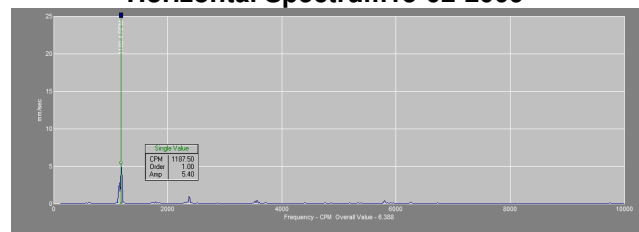
**Fig 16**  
**Fan Shaft Non Drive End Bearing**  
**Horizontal Spectrum 15-02-2009**

After the trim balance the overall vibration in the horizontal direction reduced to 6.3mm/s with a 1x (1188rpm) frequency of 5.4mm/s (See Fig 16 Fan Shaft Non Drive End Bearing Horizontal Spectrum).

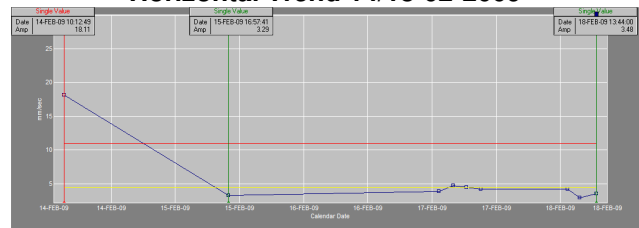
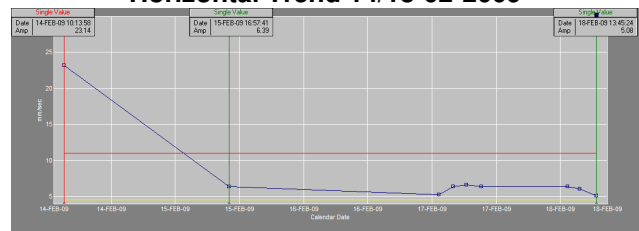
The unit was then monitored at various times over the following days until running back at full temperature and the line back in full production. The vibration remained at the improved level (See Fig 17 & 18 Fan Shaft Bearing Horizontal Trends)

Although the readings on this unit are at a satisfactory level, further improvements could be made if as discussed during the site visit, the base is secured to the platform, and the drive belt size (rpm) is changed to eliminate the 'beat frequency'.

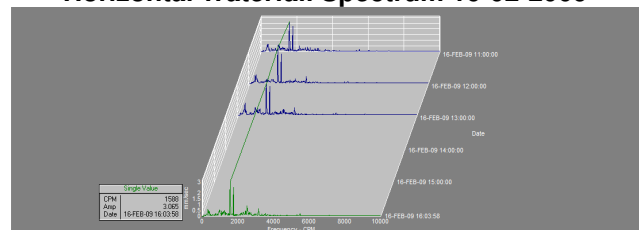
**Fig 19**  
**Fan Shaft Drive End Bearing**  
**Horizontal Waterfall Spectrum 16-02-2009**

The overall vibration in the horizontal direction was <5mm/s with a 1x (1587rpm) frequency of 3mm/s (**See Fig 19 Fan Shaft Drive End Bearing Horizontal Waterfall Spectrum**).

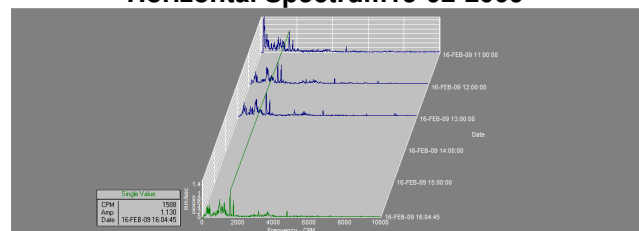
**Fig 20**  
**Fan Shaft Non Drive End Bearing**  
**Horizontal Spectrum 15-02-2009**

The overall vibration in the horizontal direction was <4mm/s with a 1x (1587rpm) frequency of 1.1mm/s (**See Fig 20 Fan Shaft Non Drive End Bearing Horizontal Waterfall Spectrum**).

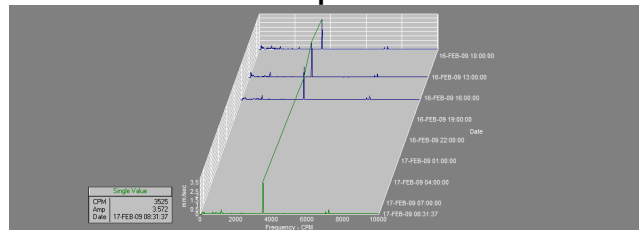
**Fig 21**  
**Motor Non Drive End Bearing**  
**Horizontal Waterfall Spectrum 16/17-02-2009**

The overall vibration in the horizontal direction was <4.2mm/s with a 1x (3530rpm) frequency of 3.5mm/s (**See Fig 21 Motor Non Drive End Bearing Horizontal Waterfall Spectrum**).

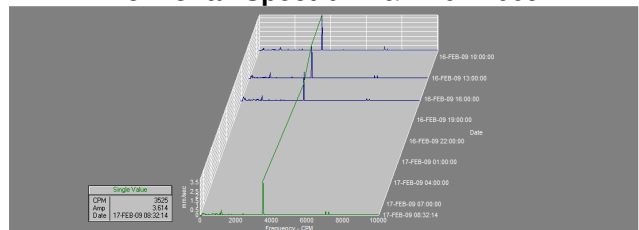
**Fig 22**  
**Motor Drive End Bearing**  
**Horizontal Spectrum 16/17-02-2009**

The overall vibration in the horizontal direction was <4.2mm/s with a 1x (3530rpm) frequency of 3.6mm/s (**See Fig 22 Fan Shaft Non Drive End Bearing Horizontal Waterfall Spectrum**).

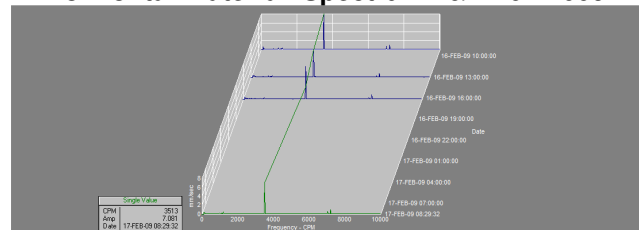
**Fig 23  
Motor Non Drive End Bearing  
Horizontal Waterfall Spectrum 16/17-02-2009**

The overall vibration in the horizontal direction was <8.3mm/s with a 1x (3525rpm) frequency of 7mm/s (**See Fig 23 Motor Non Drive End Bearing Horizontal Waterfall Spectrum**).

The overall vibration in the vertical direction was <9mm/s with a 1x (3525rpm) frequency of 8.1mm/s.

Using ISO Standard 2372 the drive end vertical and axial vibration on this unit is at an unacceptable level. These levels may be improved by trim balancing the fan, however I would recommend firstly checking the flooring/structure beneath this unit is structurally sound, and there are no blockages to the air flow to and from this unit causing flow turbulence.

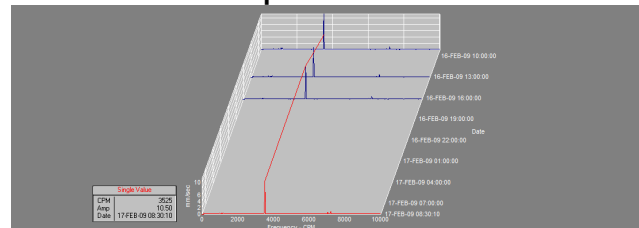
**Fig 24  
Motor Drive End Bearing  
Horizontal Spectrum 16/17-02-2009**

The overall vibration in the horizontal direction was <11.5mm/s with a 1x (3525rpm) frequency of 10.5mm/s (**See Fig 24 Fan Shaft Non Drive End Bearing Horizontal Waterfall Spectrum**).

The overall vibration in the vertical direction was <15mm/s with a 1x (3525rpm) frequency of 12mm/s.

The overall vibration in the axial direction was <14.8mm/s with a 1x (3525rpm) frequency of 13.3mm/s.
