# **Laser Alignment &** **In-situ Balance** **Report** **customer.**

The following equipment was used to carry out a Laser Alignment & In-Situ Balance procedure on the Line 2 FA102 Fan Unit at the request of Eric Paine:

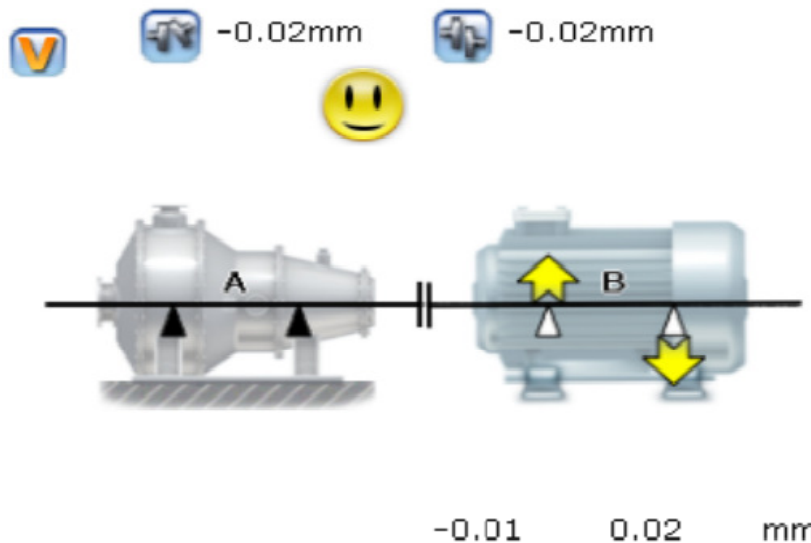
**Fig 1**

Following the coupling adjustment the laser alignment equipment was set up on the motor and intermediate shaft, and an initial set of data collected. The results showed the vertical alignment was within tolerance, see Fig 1.

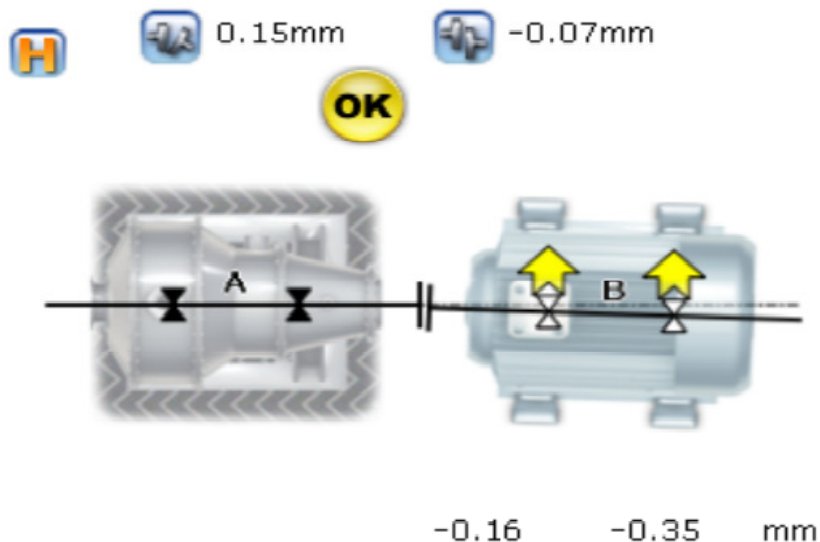
**Fig 2**

However the horizontal angular alignment required adjustment, see Fig 2.

With the soft foot at a best as attainable condition, the angular horizontal alignment was adjusted and a further set of results recorded, see Fig 5 & 6.

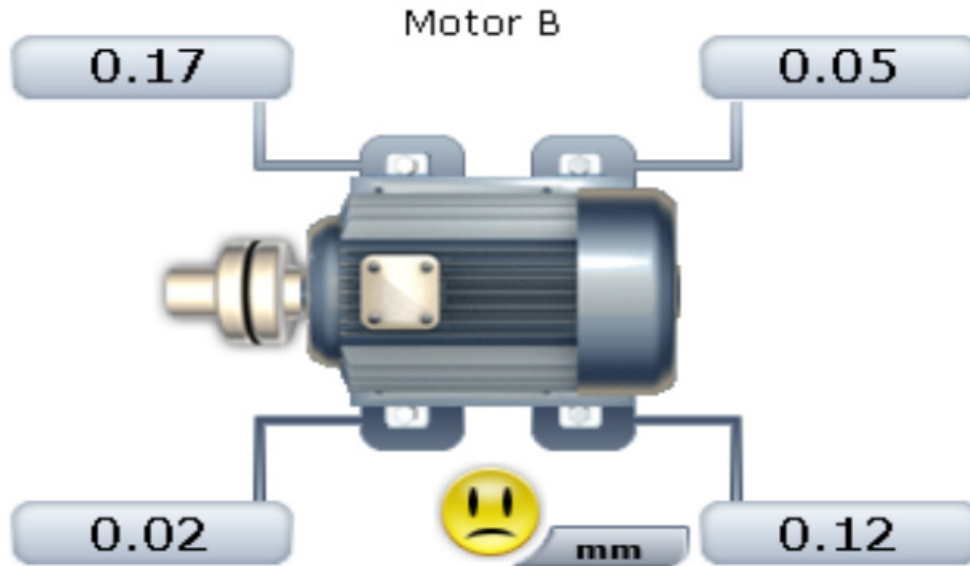
**Fig 3**

Before making any adjustments the motor was checked for soft foot, see Fig 3.

The soft foot required adjustment to the north west drive end foot of 0.10mm and the south east non drive end foot of 0.05mm. Once the adjustments had been made the soft foot was re-checked and was in a best as attainable condition, see Fig 4.
