Alignment Report

A customer.
wakefield.

NO.4 spiral compressor

5th February 2010

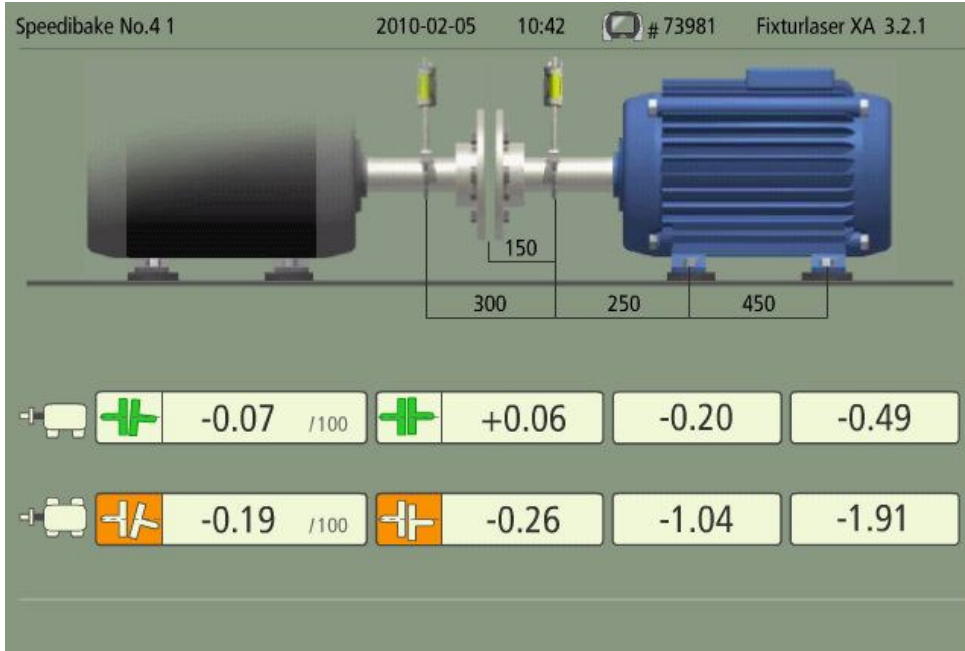
The initial readings indicated angular and offset misalignment in the horizontal direction, see diagram below.
