condition monitoring **Report**

NO. 171201 7053

customer
UK site

December 2016

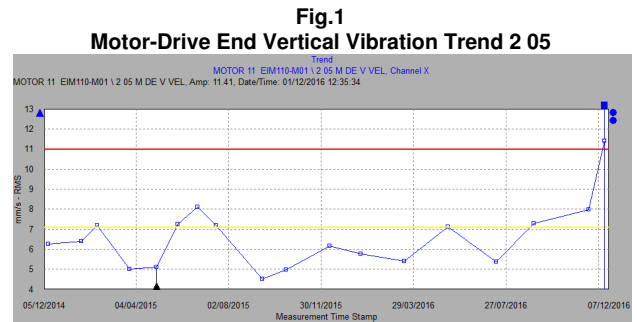
The motor has increased vibration, mainly in the vertical direction, due to structural looseness. See Fig 1.

Initially check the frame supporting pin for wear. Correct as required.

If no looseness wear is found, I would recommend the motor is removed and the gearbox input shaft checked for lift and movement, I would also check the condition of the coupling.

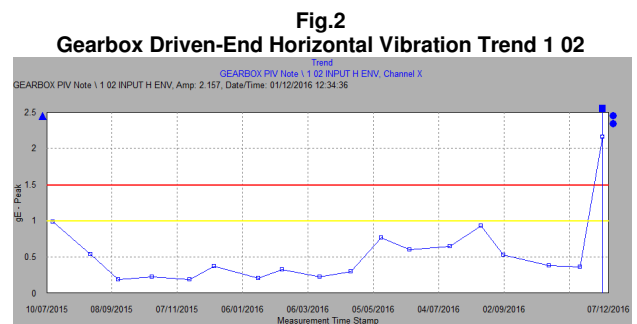
The gearbox input shaft is showing increases due to both input shaft speed vibration and looseness/movement vibration. See Fig 2.

The increased input shaft and looseness movement vibration is caused by either, or both looseness/movement of the gearbox input shaft, or structural looseness.

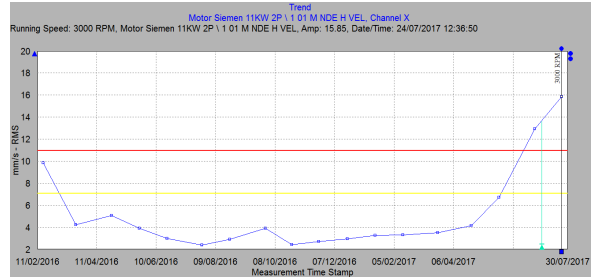
Fig. 1.
Motor Non-drive End Vibration Trend 1 01

The motor vibration is continuing to steadily increasing. See Fig's 1 & 2.

This is due to an increase in structural weakness being excited by impeller/flow vibration.

I would recommend the pump is planned into be changed.

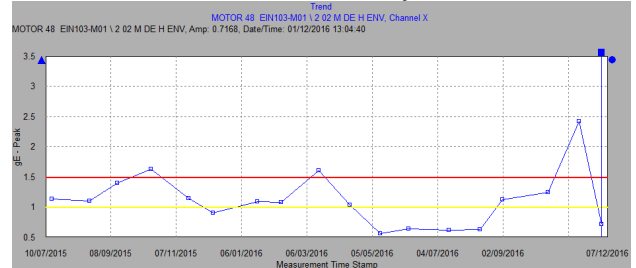
Fig.1
Motor Drive End Electrical Activity Trend 2 02 ENV

The previously reported motor electrical activity has reduced. See Fig's. 1 & 2. This will be due to the corrective work recommended in the September Thermographic report been carried out.

None. Continue in service. We will accept these readings as it's new baseline levels.

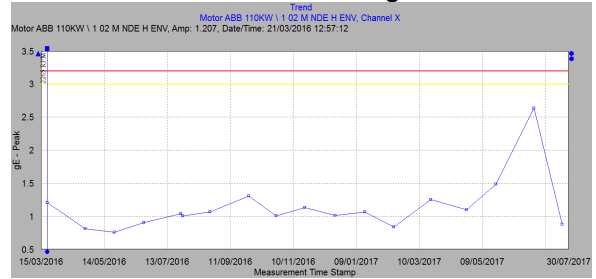
Fig. 1.
Motor Non-Drive End Bearing Trend 1 02

The motor bearing readings have reduced to acceptable levels since they have been greased. See Fig. 1.

None. Continue in service.

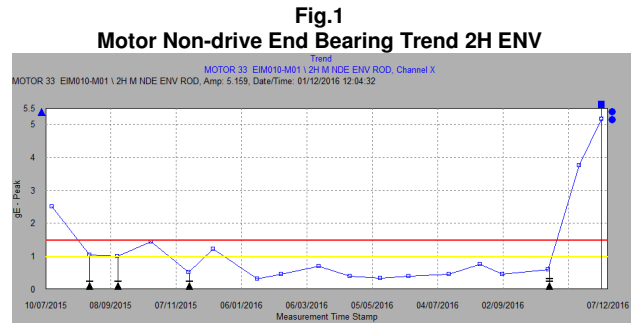
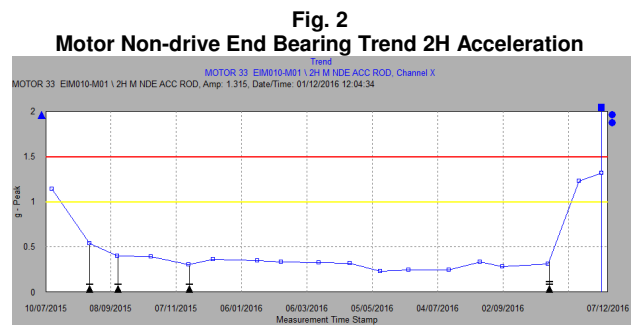
The motor non-drive end high frequency readings have increased again, due to bearing wear. See Fig's. 1 & 2.

Change the motor, or the non-drive end bearing in-situ as discussed.
